Understanding Details of Cavitation

Anne Boorsma¹, Stewart Whitworth¹

¹Technical Investigation Department, Lloyd's Register, London, UK

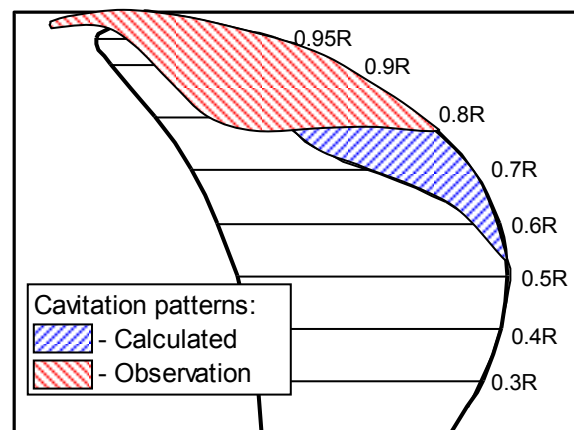
Figure 1: Prediction of cavitation on an LNG ship propeller: calculation with lifting surface method vs. experience

The lifting surface codes were quite capable of predicting the overall propeller cavitation development but had problems, in particular, with smaller scale cavitation developments and the prediction of tip flows as illustrated in **Figure 1**. This resulted in erroneous hull pressure predictions.

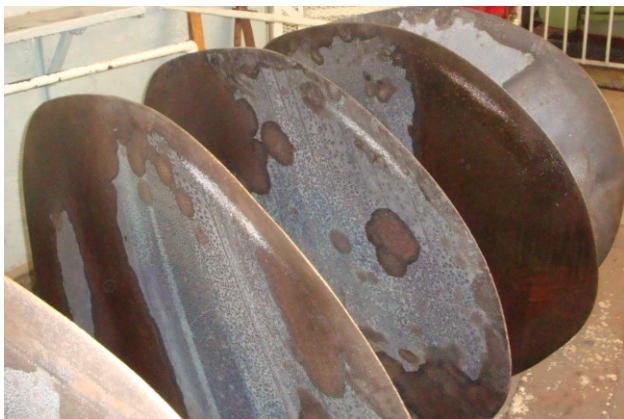
Figure 2: Cavitation damage on a dredger propeller

Figure 2 shows a set of blades from a dredger propeller with damage in a long streak just behind the leading edge on the pressure side of the propeller. The depth of the damage had reached 3.7mm after 1 year in service. The location and shape of the eroded area suggested erosion occurred during low pitch and high shaft speed conditions. On dredgers, such operating conditions would occur during dredging which would be a considerable part of the service time of the vessel. When operating at low pitch and high shaft speed, a cavitating leading edge vortex can occur on the face of the blade then disintegrate, causing high pressure impacts in the area where erosion is observed. It was recommended to re-design or modify the blades to better suit this condition.

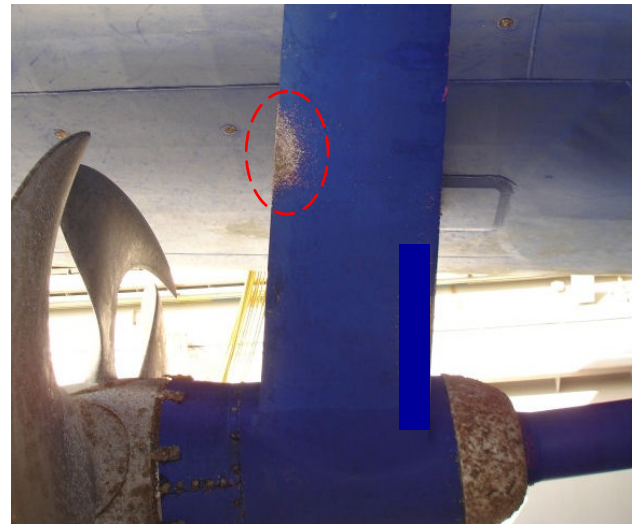
Figure 3 shows a shaft bracket on a small cruise vessel. Paint removal in way of the propeller tips was noted directly after the sea trial and, unusually for cavitation damage, it did not appear to originate from the leading edge of the bracket but instead from the trailing edge. When a second inspection at the 1 year dry docking revealed that damage had not progressed, it was concluded that erosion could have occurred during extreme conditions of the sea trial. This extreme condition was likely a hard astern manoeuvre during which a cavitating vortex from the propeller impinged on the shaft bracket. It was thus recommended to avoid hard astern manoeuvres where possible.

Figure 3: Cavitation damage on an A-bracket

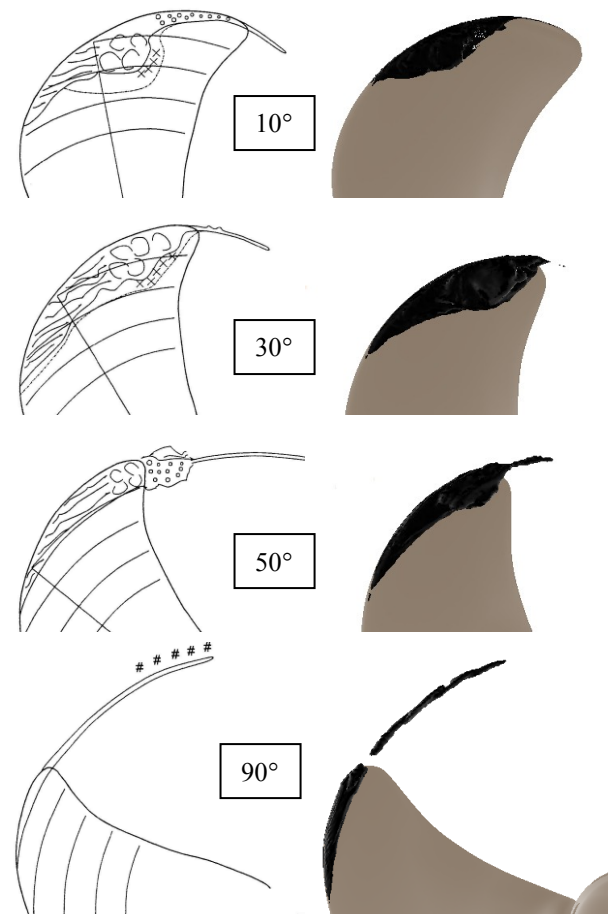
In **Figure 7**, a sheet cavity grows from the leading edge of the blade as the propeller traverses the wake peak. As the blade passes out of the wake peak much of the on-blade sheet cavitation collapses. However, a significant volume of cavitation survives off the blade. This interacts with the tip vortex before also collapsing.

Figure 7: Growth and collapse of cavitation on and around the propeller of the LNG carrier from cavitation tunnel tests (left) and CFD analysis

The cavitation around the propeller of the LNG carrier was simulated using the commercial solver STAR-CCM+ with an additional modification to the cavitation model that aims to promote cavitation growth in the core of the tip vortex. Despite recent advances in computing power, resolving the tip vortex in a CFD simulation is usually impractical to achieve due to the very small diameter of the core of the vortex in which the pressure is predicted to be low enough for cavitation to be generated. **Figure 7** compares the model scale cavitation tunnel observations with the ship scale CFD predictions.

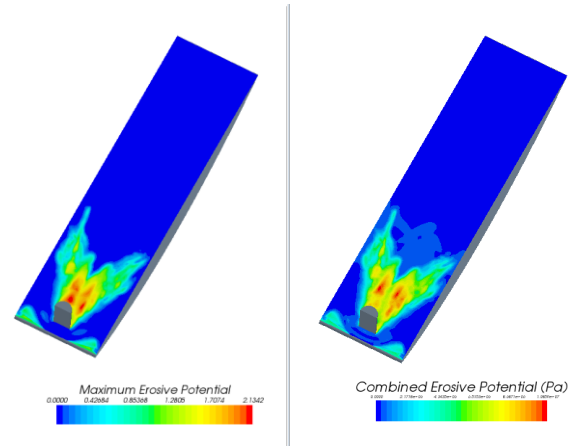
Instead, a more accurate description of the erosive potential of the flow was required, based on the understanding that cavitation is most likely to be erosive when the cavity collapse accelerates rapidly towards the surface (Franc & Michel 2004). Various iterations around this theme were explored, two of which are shown in **Figure 10**. When compared to the experimentally-determined erosion pattern in **Figure 9**, it is clear that the erosive potential functions provide a far more accurate prediction of the locations susceptible to erosion than the simple pressure footprint method.

Figure 10: Comparison of two variations of calculated erosive potential

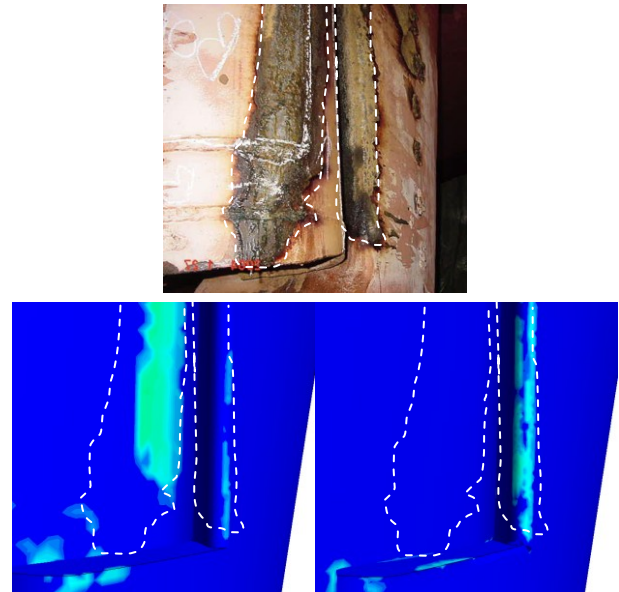
Erosion damage around the rudder gap is shown in **Figure 16**. This occurs both forward of the gap, on the rudder horn, and aft of the gap, on the rudder blade. The predictions of erosive potential indicate that the former is likely to be predominantly generated when the rudder is turned to port and the latter when it is turned to starboard.

Figure 16: Cavitation erosion around gap between rudder and horn (top) and predicted erosive potential of flow as calculated when rudder is turned 4° to starboard (left) and 4° to port (right)

Overall, the predictions of erosive potential provide a good indication of the regions of the rudder in which erosion is likely to take place. However the details of the observed erosion patterns are not fully captured in this particular example. There are considered to be two possible reasons for this. Firstly, it is impossible to know under which operating conditions the observed rudder erosion occurred. These analyses were performed at the design speed and at only two rudder angles yet it is probable that cavitation erosion occurs across a range of speeds and rudder angles. Secondly, by employing a relatively coarse mesh and a RANS turbulence model, these simulations could not be expected to predict the small-scale dynamic flow features that were captured in the laboratory test case and which are known to be important in determining whether a cavitating flow is erosive. It is the intention of the authors to repeat these simulations using a finer mesh and a DES turbulence model to assess the possible benefits of adopting a more detailed approach.
