A Qualitative Study on the Relationship Between Cavitation Structure and Erosion Region around a 3D Twisted Hydrofoil by Painting Method *

Cao, Y.T.^{1,2}, Peng, X.X.^{1,2}, Yan, K.², Xu L.H.^{1,2}, Shu L.W.²

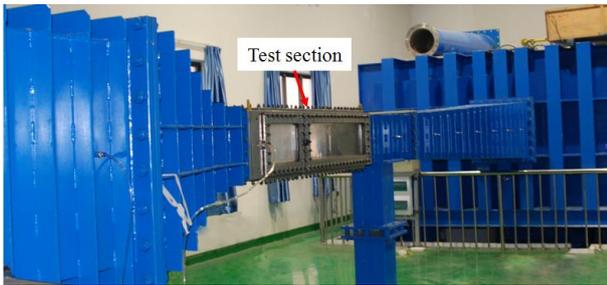
Figure 1 The high speed cavitation tunnel in CSSRC.

Cavitation tests were conducted in a high speed cavitation tunnel (as shown in Figure 1) located in China Ship Scientific Research Center (CSSRC). The test section is composed of 8 perspex window which permits to observe cavitation structures from different sides. The length of test section is 1600mm and the size of the square cross section is 225mm×225mm. The maximum flow velocity can reach 25m/s and the background pressure can be adjusted from 5kPa to 500kPa, which allows the cavitation number defined as formula 1 to be easily changed. Above all, this tunnel has a fast degassing system allowing to degass the water in limited time.

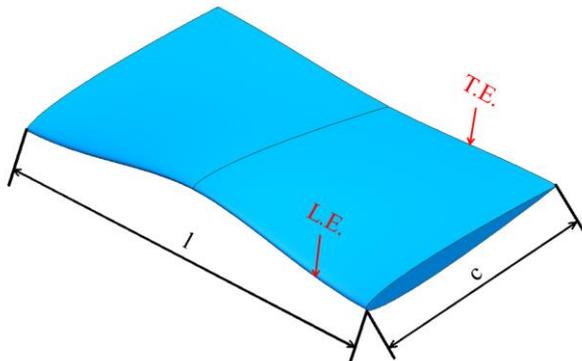
Figure 2 A sketch of NACA0009 3D twisted hydrofoil.

The test model used in this test is a NACA0009 three dimensional twisted hydrofoil (as shown in Figure 2) with a cord length of 112.5mm and a spanwise length of 225mm. It is a symmetric hydrofoil with spanwise varied attack angle and the maximum angle of 11 degree in the middle. Before test the foil surface was coated with paint made of oil and some powder. Then it was left in the air to dry naturally. The purpose of painting is to use the peeled coatings to show the high erosion risk region.

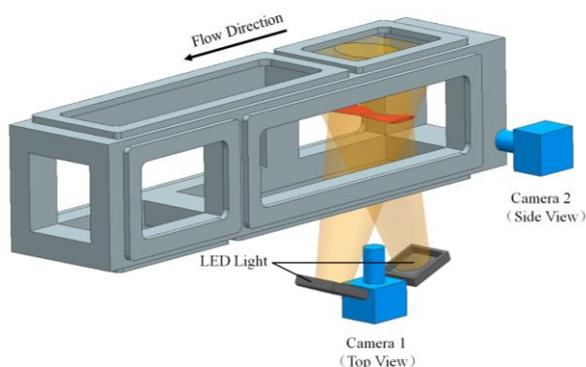
Figure 3 A sketch of the setup of high speed cameras.

The cavitation structures were observed synchronously by two high speed cameras from the bottom and side of test section, which consequently can get both the top view and side view of cavitation structures around the hydrofoil. Two LED lights provide light for high speed cameras. The images were recorded at a frame rate of 2000 fps during the experiment.

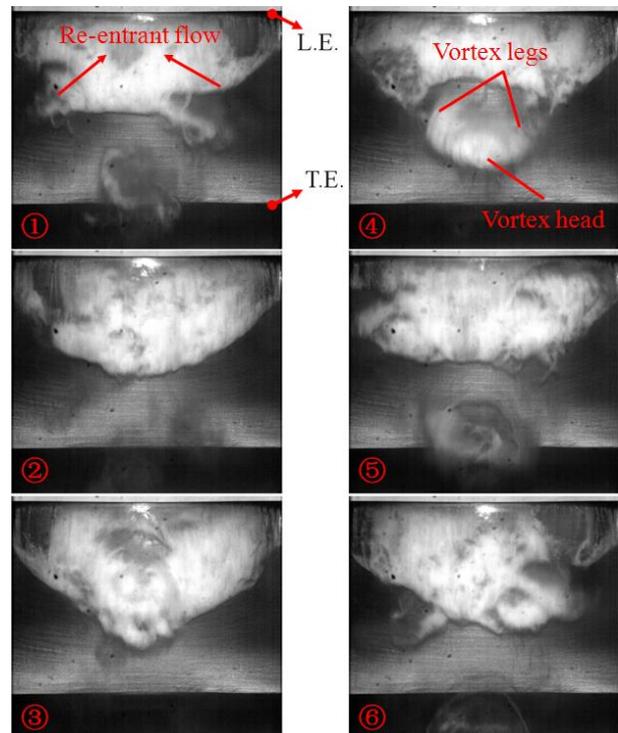
Figure 4 Behavior of cloud cavitation

(Top view, $U = 14m/s$, $\sigma = 1.2$)

From the high speed observation, it can be found that the shedding process of large scale cloud cavitation around 3D twisted hydrofoil is quasi-periodic. As is shown in figure 4 (Top view) and figure 5 (Side view), the cavitation sheet attaches on the surface of hydrofoil to the leading edge (①). Re-entrant flows (marked with arrows) beneath the sheet form in both side of the rear area of this sheet, then they move forward to the center of hydrofoil and gather together in the spanwise symmetric plane (②). Subsequently, the converged re-entrant flow cuts off the cavitation sheet (③), which seems to be the generation mechanism of large scale cavitation. And then the detached part of the sheet moves downstream with the incoming flow and evolves into a U-shaped vortex structure (④). The U-shaped vortex structure continues to be convected downstream and damps in the downstream (⑤,⑥).

(2) Intensify the local aggressiveness of cloud cavitation. As is described above, U-shaped vortex can concentrate bubbles to the center of vortex core, thus enhances the local collapse density at the hydrofoil surface where the two vortex legs attach. Therefore, the local aggressiveness of cloud cavitation is intensified because of the two legs of U-shaped vortex are both absorbed on the wall (Shown in figure 4 and figure 5 ④-⑥).

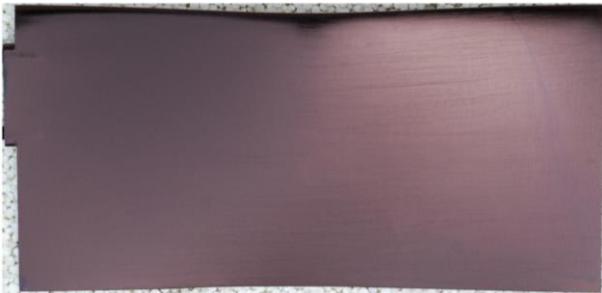
Figure 6 The surface coating status before test.
($U = 14m/s$, $\sigma = 1.2$)

As is shown in figure 6, before test the hydrofoil surface is uniformly coated with paint and left in the air dry naturally. Thus a good polished surface can be obtained to compare with that of after test so as to find out the regions in high erosion risk.

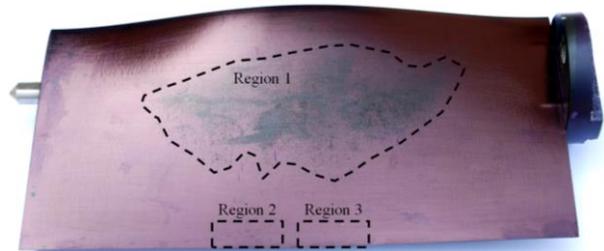
Figure 7 The surface coating status after 3 hour's test.
($U = 14m/s$, $\sigma = 1.2$)

Figure 7 shows the surface coating status after 3 hour's test at $U = 14m/s$, $\sigma = 1.2$. As is displayed that there are mainly 3 regions peeled by cavitation structures. Region 1 is the most severe part and the peeled area appears in continuous, which means that this region is in high erosion risk. In this paper, it is assumed that cavitation erosion was caused by the collapse of micro bubbles, regardless of whether the impulse pressure was generated by micro jet or shock wave. From the cavitation appearance depicted in figure 4 and figure 5, we can see that this region is corresponding to the unsteady part of sheet cavitation where the cloud cavitation comes into

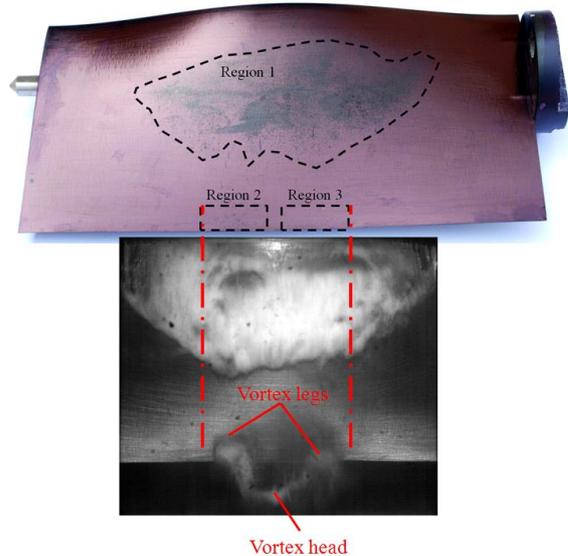
Figure 9 Comparison of cavitation structure and erosion region shown by paint loss. ($U = 14m/s$, $\sigma = 1.2$)

Besides the rear part of sheet cavitation, another two coating peeled regions (Region 2 and Region 3) can be found on the surface of hydrofoil. These two regions correspond to the area where the two legs of U-shaped vortex pass (Shown in figure 9). This area is much smaller than Region 1 and the peeled parts occur as isolated spots which can be seen more clearly in the partial enlarged view in figure 10. It means that region 2 and region 3 are also erosion risk areas but the risk is much smaller than region 1.

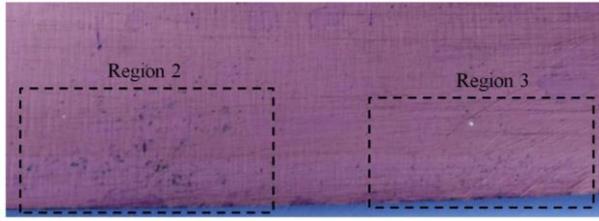
Figure 10 Partial enlarged view of surface condition after 3 hour's test. ($U = 14m/s$, $\sigma = 1.2$)

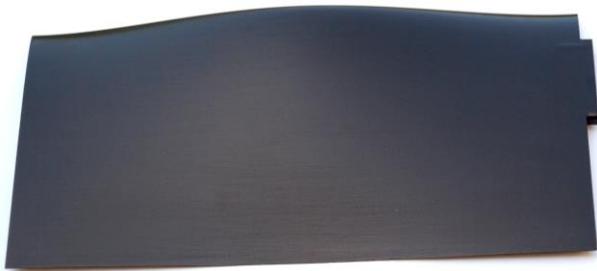
Figure 11 The surface coating status before test. ($U = 14m/s$, $\sigma = 1.3$)

These analysis was confirmed by another test condition $U = 14m/s$, $\sigma = 1.3$, at which the cavitation evolution process was very similar to last case described above. Figure 11 and figure 12 show the surface coating status before and after test respectively. The paint loss area could also be divided into 3 region, which agrees well with that of last case. This confirms that such kind of cavitating flows may share the same erosion mechanism.

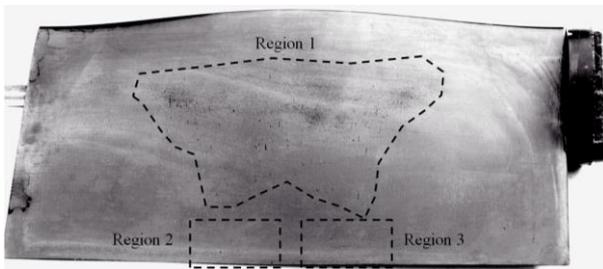
Figure 12 The surface coating status after 3 hour's test. ($U = 14m/s$, $\sigma = 1.3$)
